**ASBESTOS REINSPECTION SURVEY REPORT
GENERAL SERVICES ADMINISTRATION
GSA WAREHOUSE 6
BUILDING WA0833
AUBURN, WA**

September 30, 2009

**ASBESTOS REINSPECTION
GENERAL SERVICES ADMINISTRATION
GSA WAREHOUSE 6, (WA0833)
AUBURN, WA**

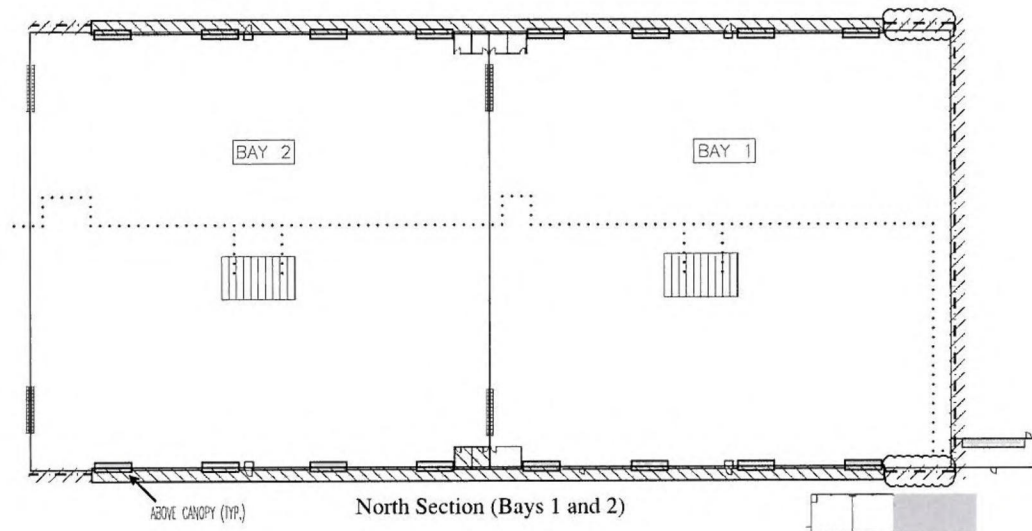
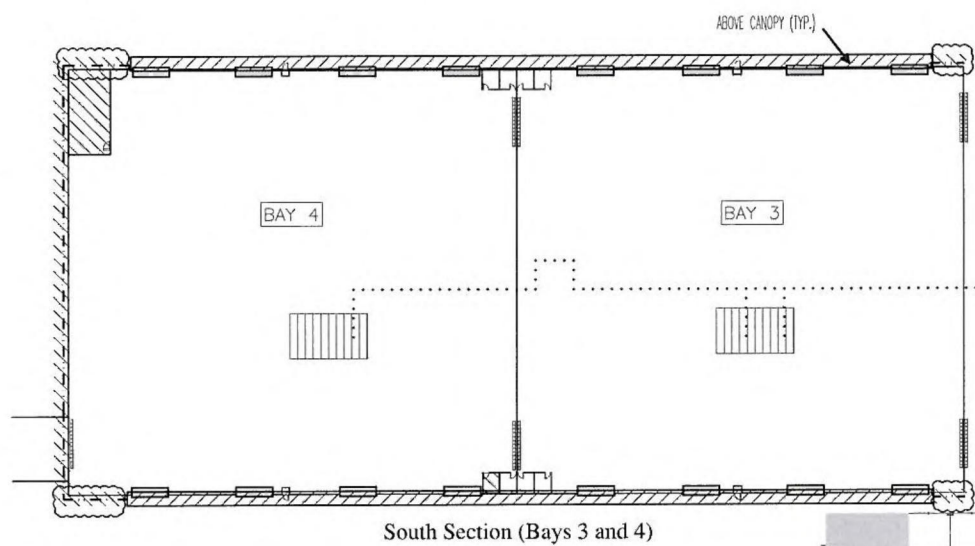
WAREHOUSE 6, 2203 C STREET SW.
 GSA BUILDING NO. WA0833
 AUBURN, WASHINGTON
 AREA OF DAMAGE

The transite siding on the south exterior portions of Warehouse 6 building was noted to have various areas of chipping and/or breaking. The black mastic beneath non-ACM VFT in the Restroom of Bay 2 in the Building had been damaged by water. The off-white window putty on portions of the windows located at the southwest corner of the building was noted to have areas of flaking. Refer to drawing AD 1 (Appendix H) for approximate locations of the damaged ACM. Refer to Appendix A, Reinspection Physical Assessments of Asbestos-Containing Materials Sheet for detailed information and cost estimates.
